ARBORIST REPORT

**PLACER COUNTY LAND DEVELOPMENT BUILDING
DEWITT CENTER, AUBURN, CA**

**Hideo Ray Yamasaki, ASLA
Certified Arborist #WC-1036
Yamasaki Landscape Architecture
Dated: September 17, 2002**

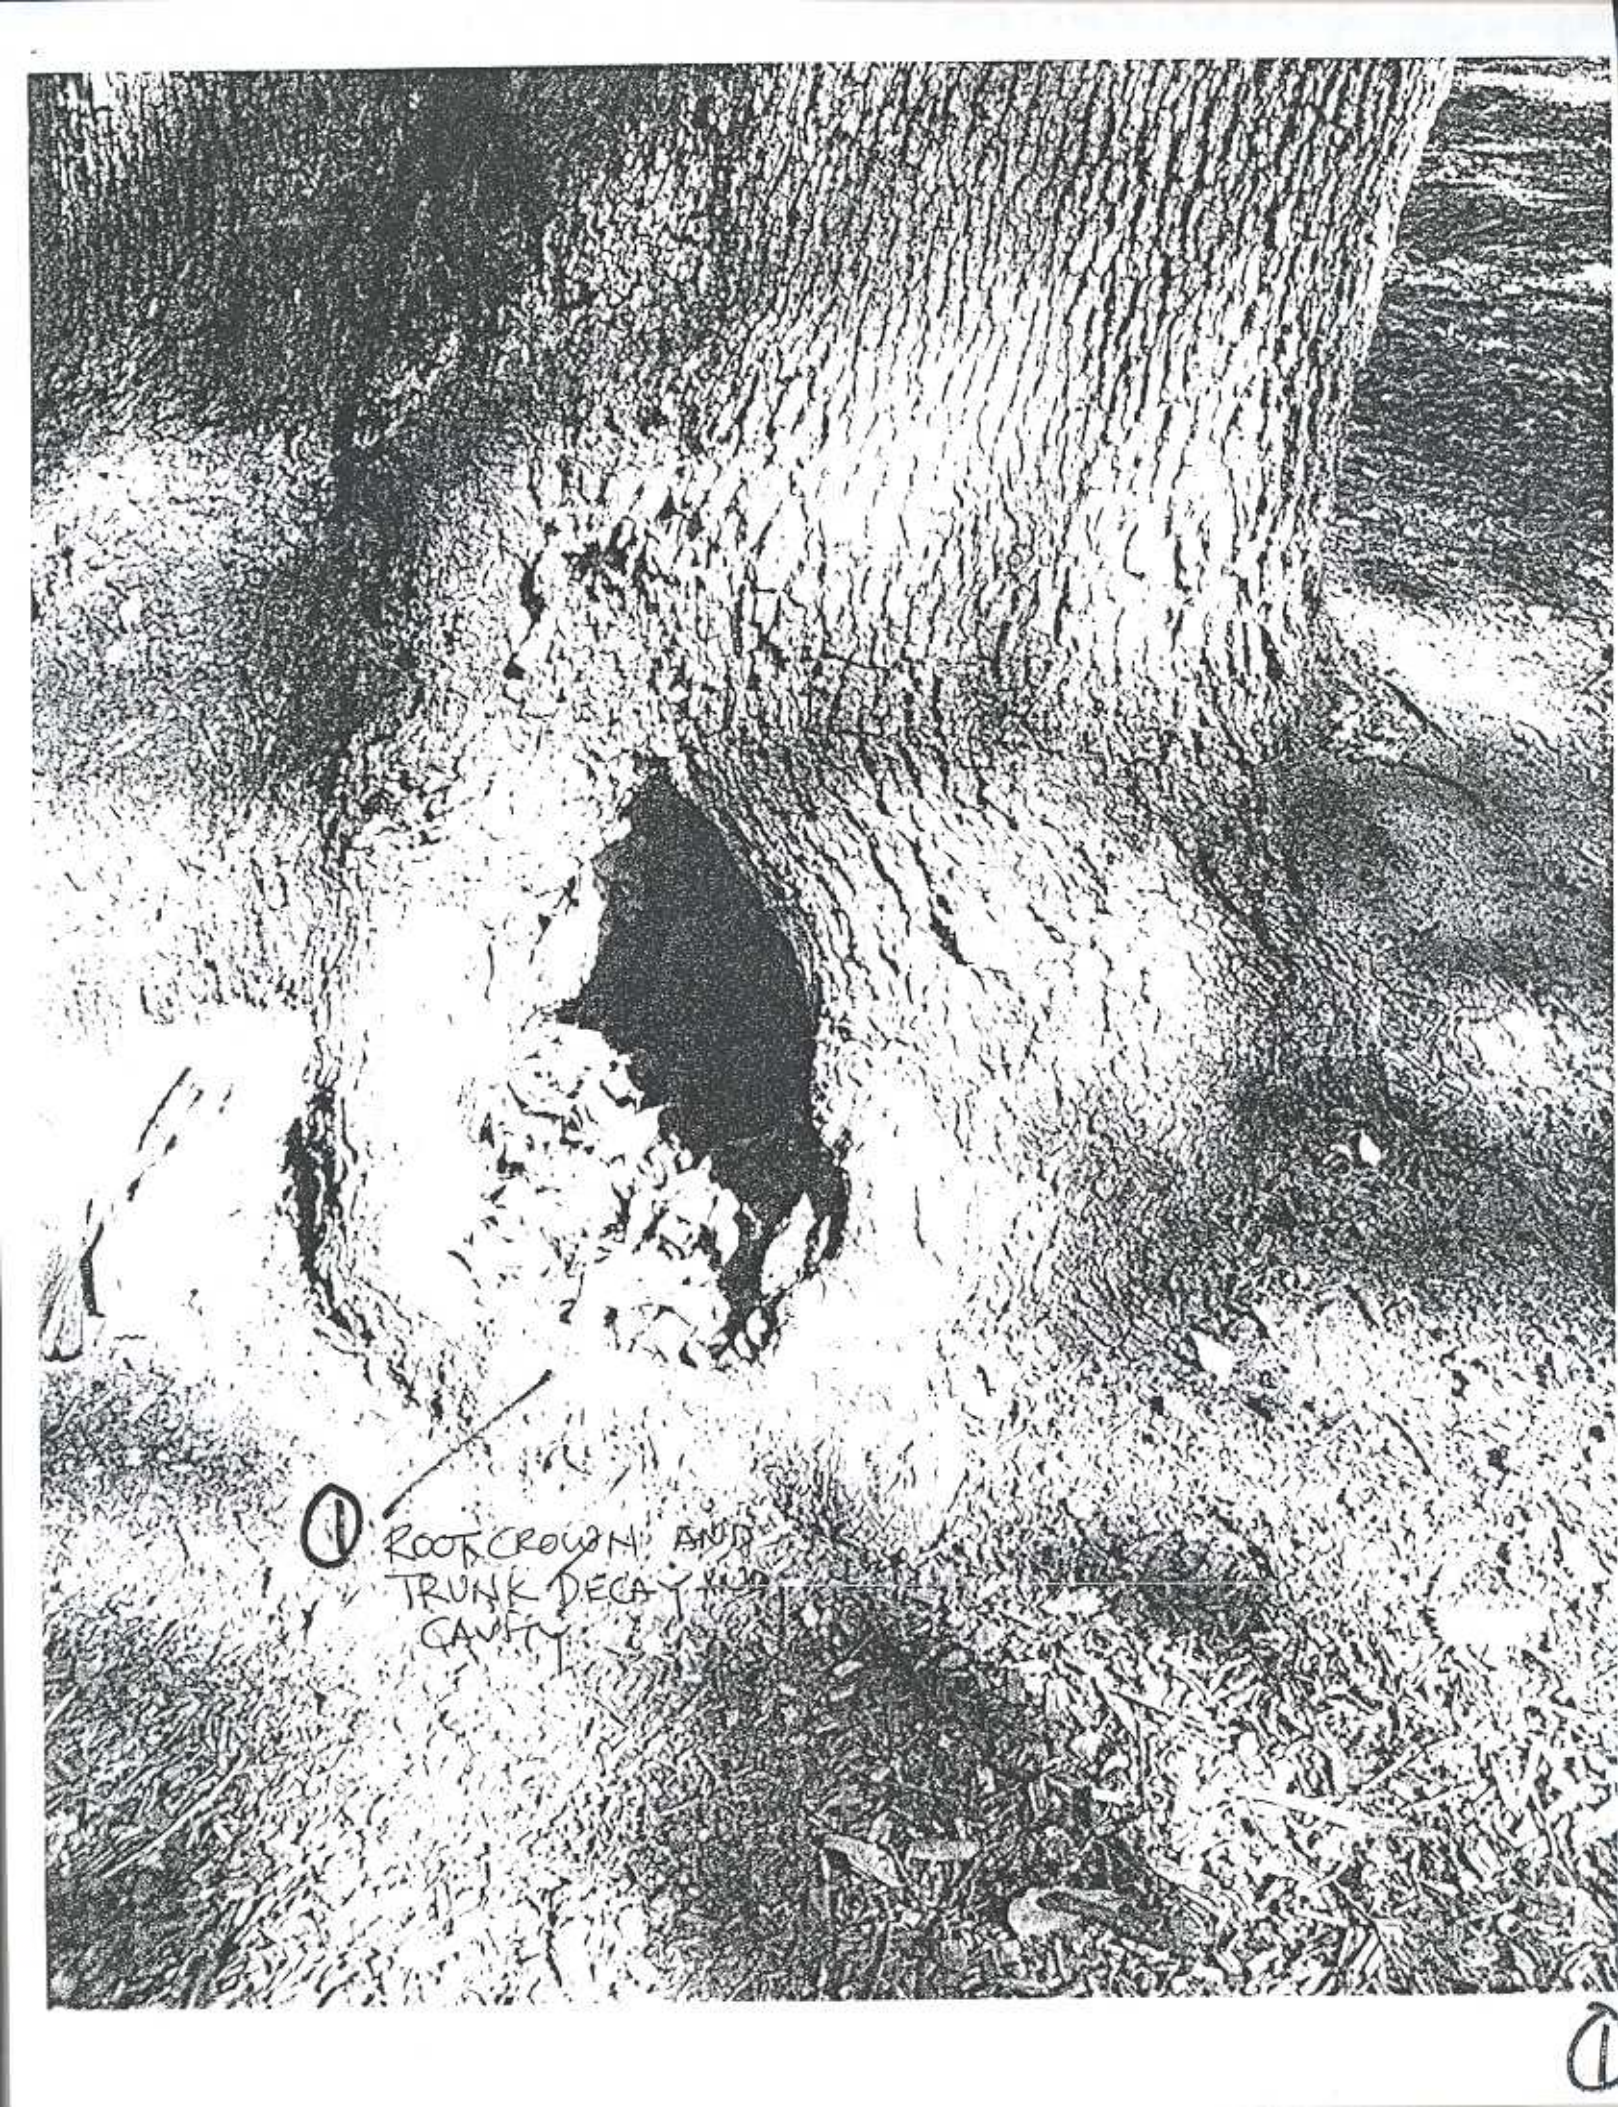
In view of the extensive construction activity proposed in the vicinity, and the over all structure health and prognosis for longevity, It is recommended that this tree be removed due to Root Crown decay.

As noted in Bob Henwood study thickness of sound wood in the trunk is as little as 6" because of the Root Crown decay cavity.

① ROOT CROWN AND
TRUNK DECAY AND
CAVITY
